Case 357 : Narrative

Case Vehicle (A): 2001 Ford	Vehicle (B): 1992 Pontiac
Type: Taurus, 4-door sedan	Type: Grand Am, 2-door coupe
Driver: 38-year-old female	Driver: 35-year-old female
CDC: 12-FDEW-3	CDC: 12-FDEW-5

This is a fatal crash. The driver of vehicle (B) died of injuries sustained in this two-vehicle head-on crash.

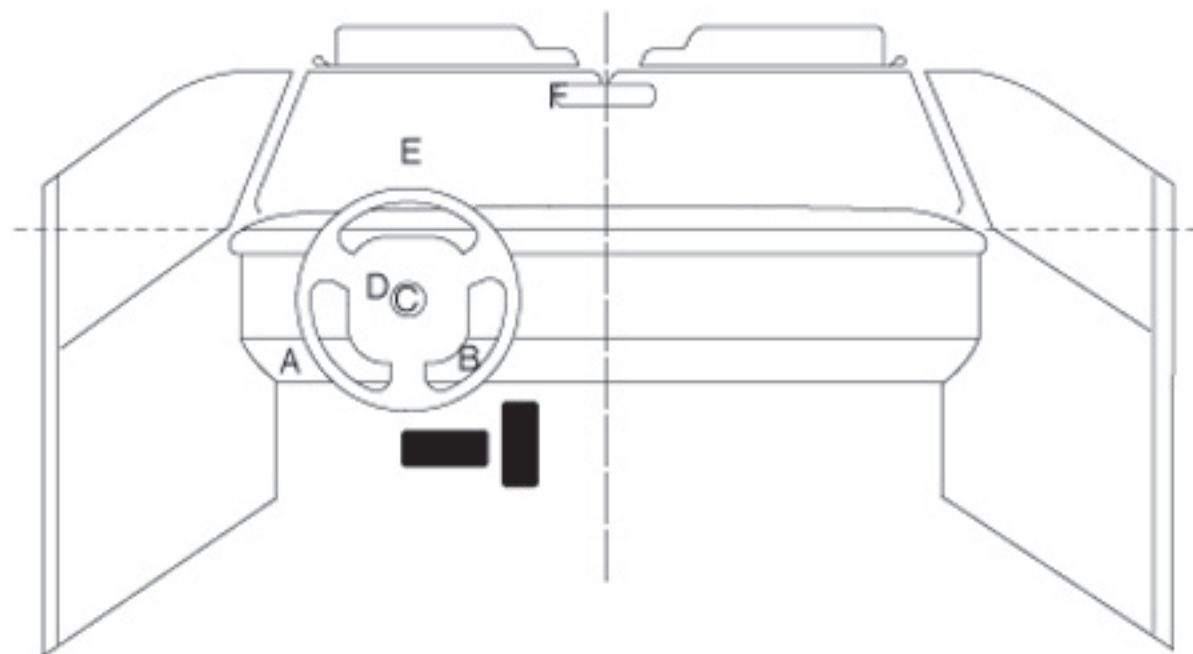
Driver Airbag

- A = knee bolster, deformed**
- B = steering coulumn, cloth transfer**
- C = airbag, blood stain**
- D = upper SW airbag flap, scuff**
- E = W/S in front of SW, spiderweb crack**
- F = RV mirror, cracked**
